# UNDERWATER BRIDGE INSPECTION REPORT

STRUCTURE NO. 7137

CR NO. 32

WATSON SAG CHANNEL

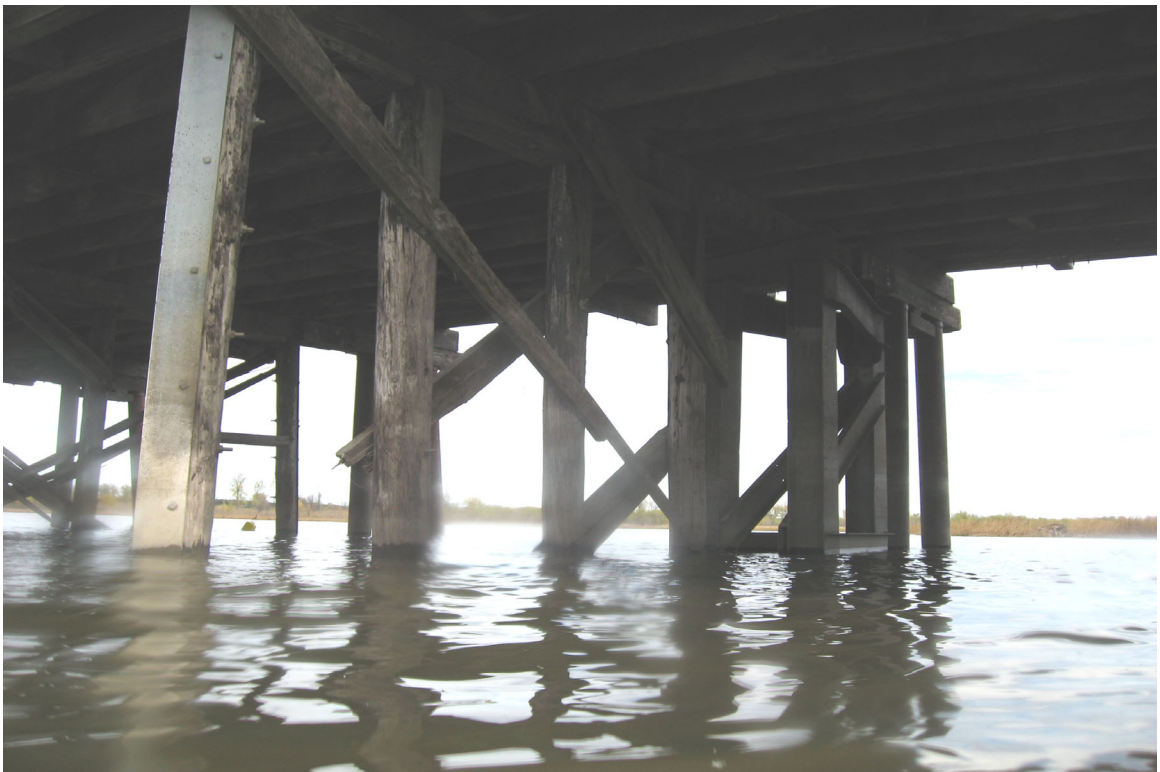
Photograph 2. View of Piers 2, Looking Northeast.

- (B) In numerous locations across the structure, the timber bracing was split through the pile fasteners and/or broken off completely.
- (C) The steel piles were generally in good condition with light corrosion observed from the waterline to the channel bottom, with some random pitting having a maximum penetration of 1/16 inch and with nodular corrosion up to 1/8 inch thick over 10 to 25 percent of the pile surface area. Nodular corrosion is primarily on three steel H-piles at Pier 2.

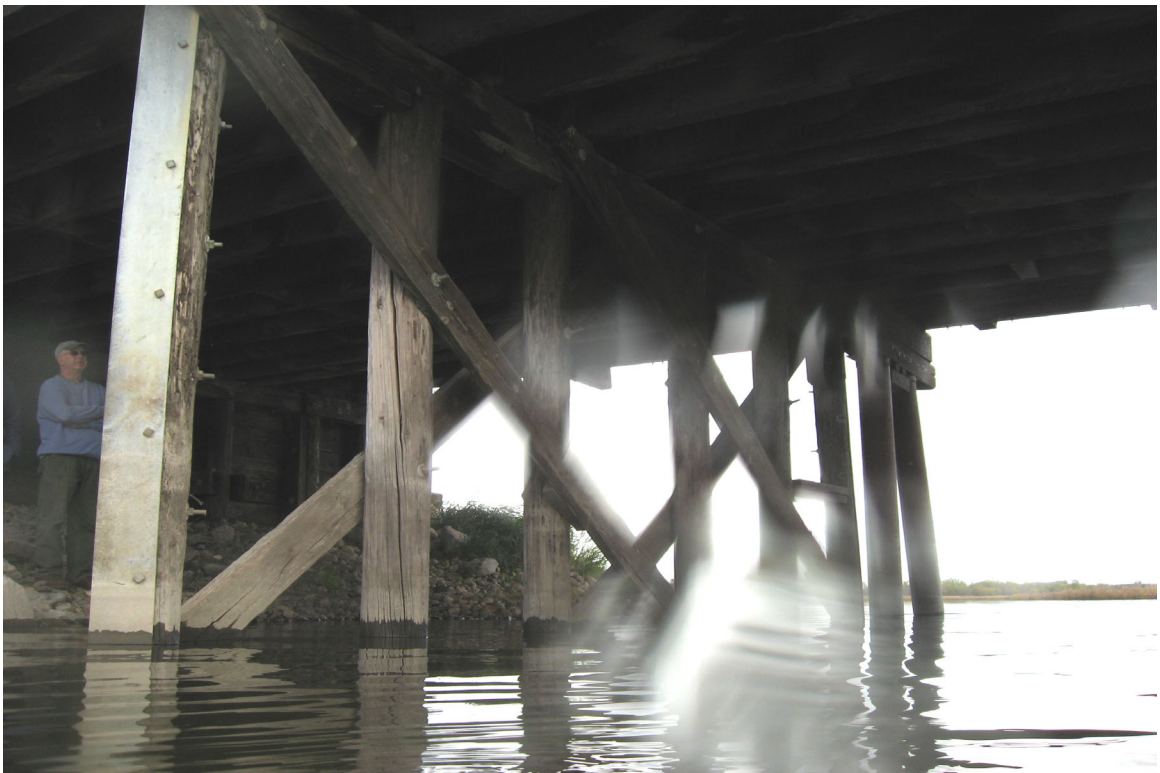
Photograph 6. View of Pier 6, Looking Northeast.

- (D) Two piles were split above the waterline at Pier 6. Pile B was split from the top of the pile to 2 feet above the waterline with a maximum width of 3/4 inch and up to 3 inches of penetration. Pile D was split from the top of the pile to 8 feet above the waterline with a maximum width of 1/2 inch and up to 2 inch of penetration.

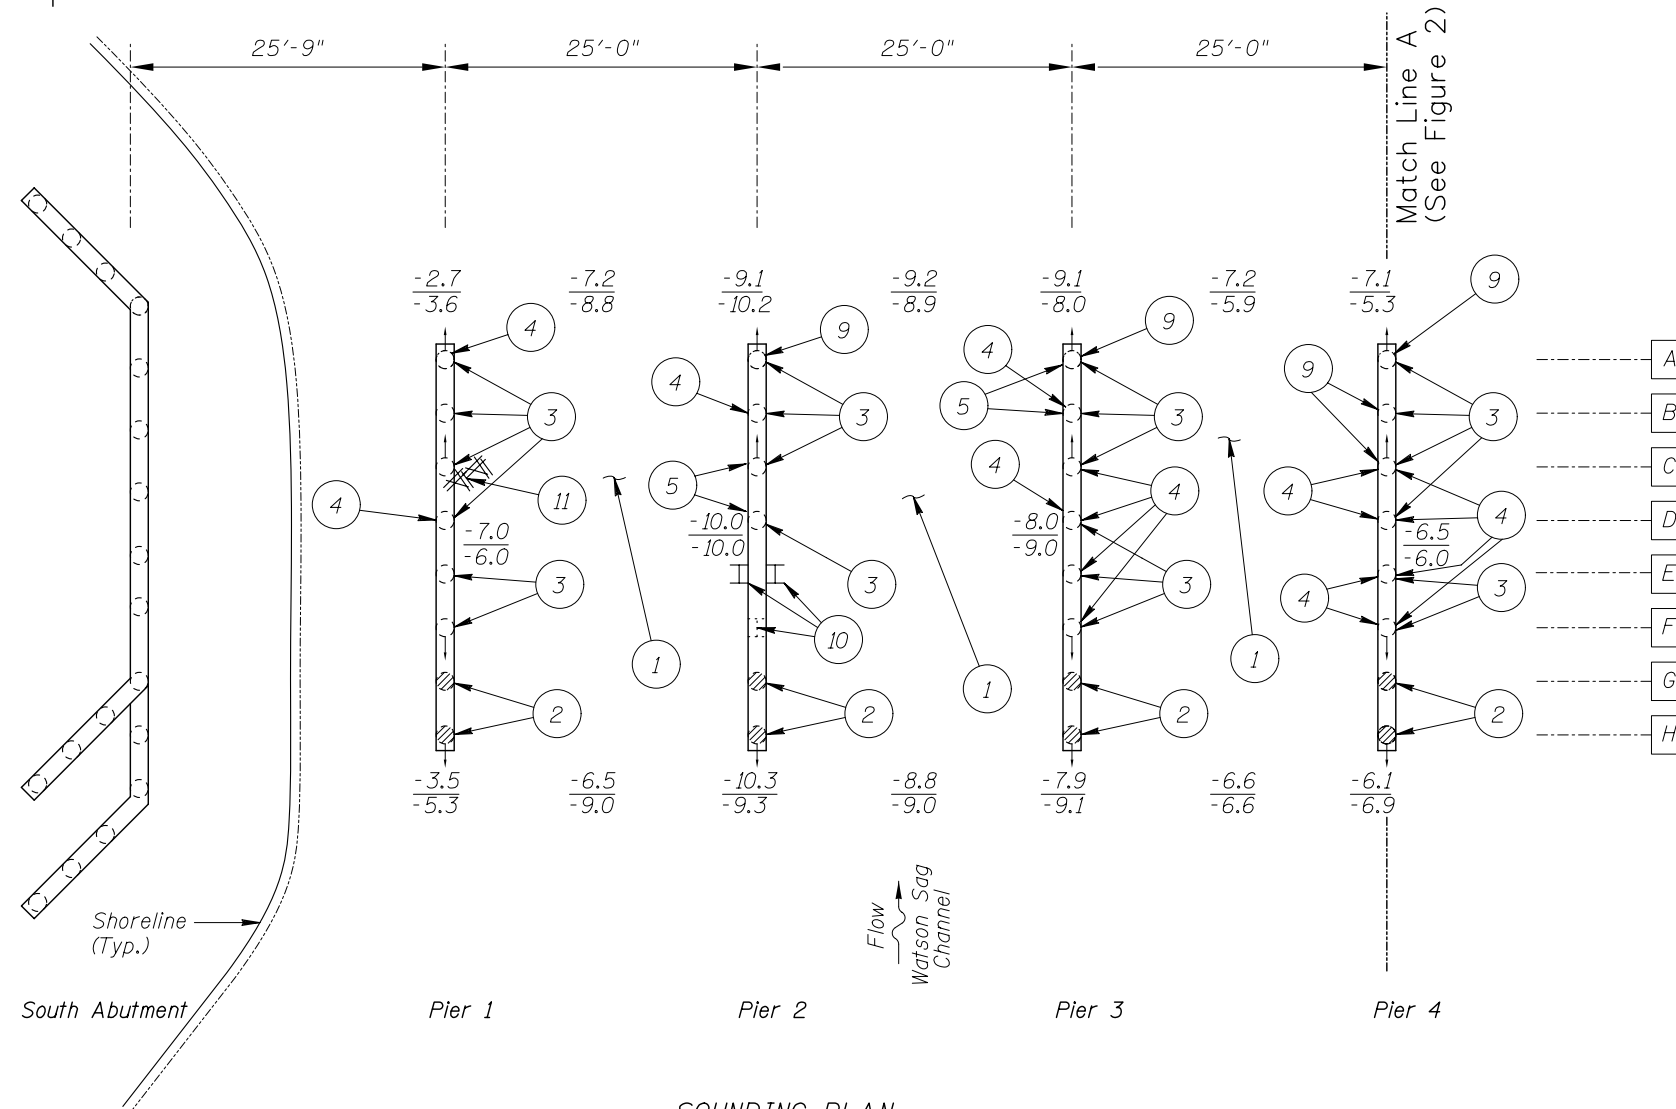
**INSPECTION AND SOUNDING PLAN**

- 1 The channel bottom material consisted of sandy silt and scattered 6 inch diameter stones with up to 3 inches of probe rod penetration.
- 2 Light corrosion was observed on the steel piles from 3 feet above the waterline to the channel bottom with random minor pitting having a maximum penetration of 1/16 inch.

- 3 Minor splitting and checking of the timber piles was observed from the pier cap to the channel bottom with a maximum width of 1/4 inch and a maximum penetration of 1 inch.

- 4 Diagonal timber bracing was split through the fastener (1/4 inch width typically).
- 5 Abrasion damage observed on the timber pile, from 1 foot above the waterline to 2.5 feet below the waterline, approximately 8 inches wide with a maximum penetration of 0.5 inch, and pile section loss of 10%.

- 6 Delamination on outer shell of timber pile was observed around the waterline with maximum penetration of 1/2 inch.
- 7 Split in pile, from the top of the pile cap to 8 feet above the waterline with a maximum width of 1/2 inch and 2 inch of penetration.

- 8 Split in pile, from the pile cap to 2 feet above the waterline with a maximum width of 3/4 inch and 2 to 3 inches of penetration.
- 9 Diagonal bracing broken and no longer attached to pile.

- 10 Piles E and F at Pier 2 were replaced with three steel H-Piles connected with steel bracing. Piles exhibited nodular corrosion up to 1/8 inch thick over 10-25% of surface area below water.

- 11 Light timber debris was observed on the north side of pile.

- (A) Replace the split and/or broken diagonal timber cross bracing to restore the lateral stability of the structure.
- (B) Reinspect the submerged substructure units at the normal maximum recommended (NBIS) interval of five (5) years.

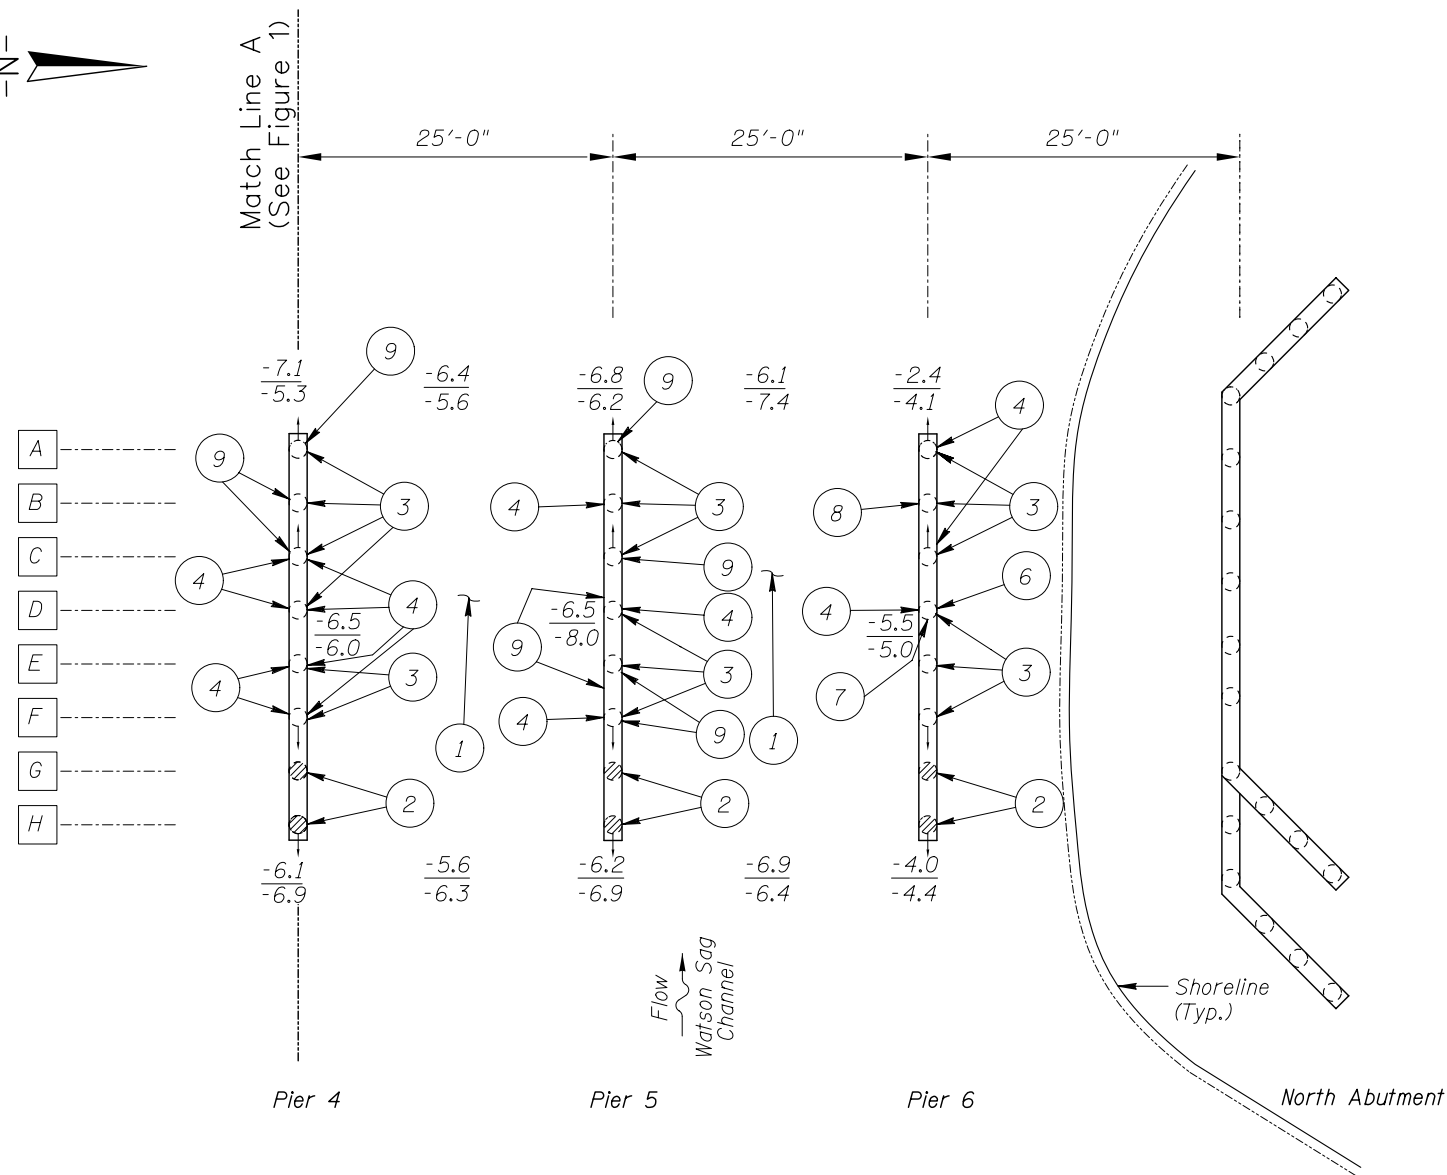
**INSPECTION AND SOUNDING PLAN**

- 1 The channel bottom material consisted of sandy silt and scattered 6 inch diameter stones with up to 3 inches of probe rod penetration.
- 2 Light corrosion was observed on the steel piles from 3 feet above the waterline to the channel bottom with random minor pitting having a maximum penetration of 1/16 inch.

- 3 Minor splitting and checking of the timber piles was observed from the pier cap to the channel bottom with a maximum width of 1/4 inch and a maximum penetration of 1 inch.

- 4 Diagonal timber bracing was split through the fastener (1/4 inch width typically).
- 5 Abrasion damage observed on the timber pile, from 1 foot above the waterline to 2.5 feet below the waterline, approximately 8 inches wide with a maximum penetration of 0.5 inch, and pile section loss at 10%.

- 6 Delamination on outer shell of timber pile was observed around the waterline with maximum penetration of 1/2 inch.
- 7 Split in pile, from the top of the pile cap to 8 feet above the waterline with a maximum width of 1/2 inch and 2 inch of penetration.

- 8 Split in pile, from the pile cap to 2 feet above the waterline with a maximum width of 3/4 inch and 2 to 3 inches of penetration.
- 9 Diagonal bracing broken and no longer attached to pile.
